The STEAM UP Project

11/12/2019

The STEAM UP Project – Case Studies from SME Industries in Greece

Energy audits in 10 SME industries in Greece

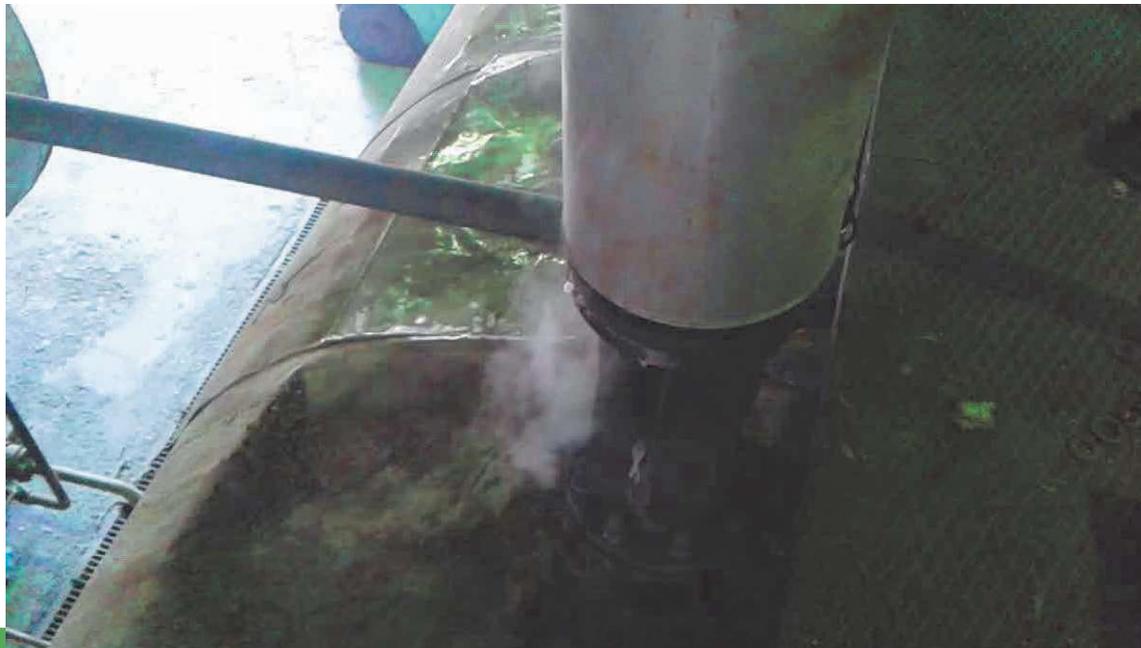
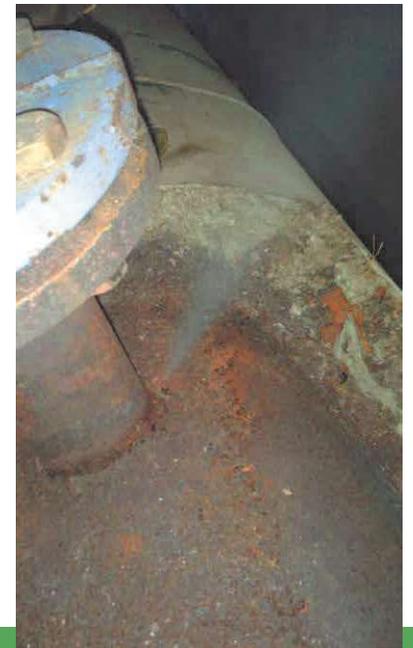
Examples of a steam boiler safety valve left permanently open in order to avoid the increase in pressure of the steam boiler instead of seeking the reasons for the pressure build-up repairing it.

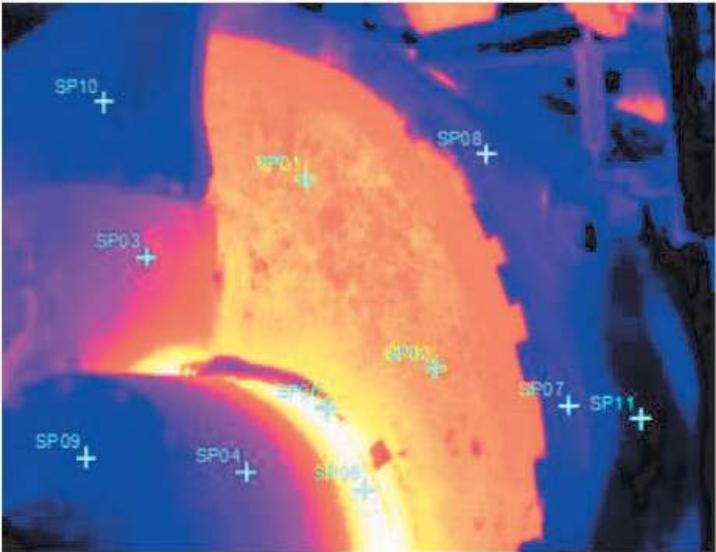
60% of the inspected plants had numerous surfaces that were not properly insulated.

Uninsulated steam boiler (back-end)
Uninsulated collector and valves

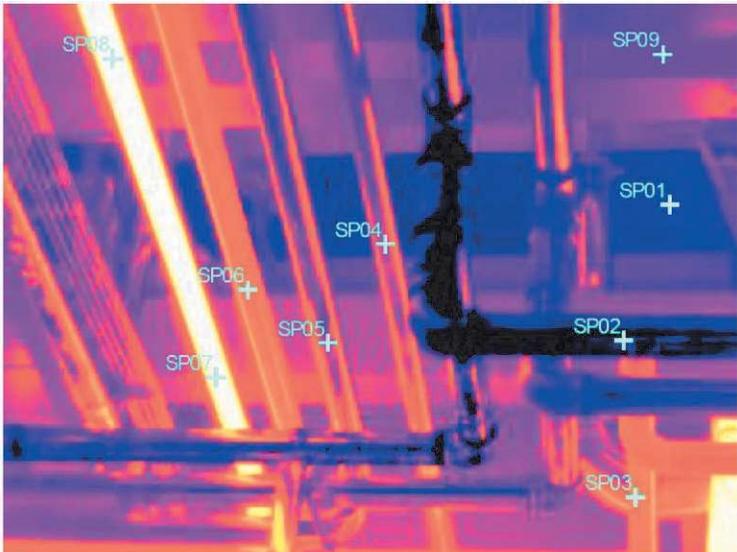
Uninsulated piping
Uninsulated tanks

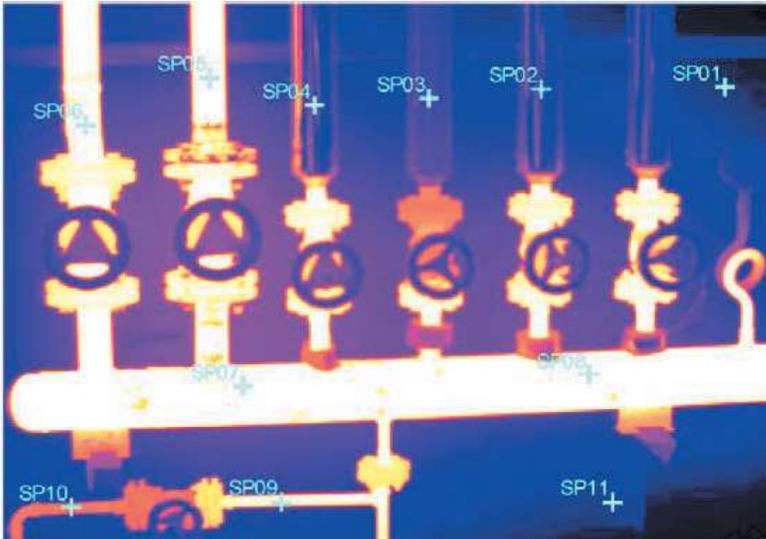
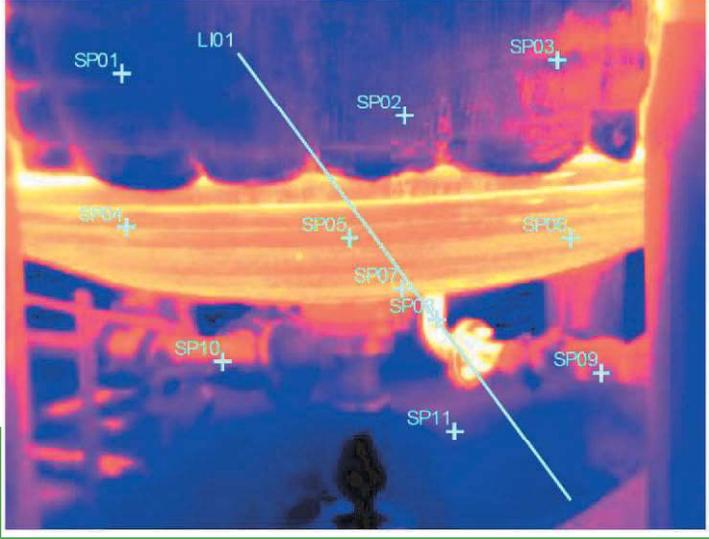
Example of properly insulated valves (with velcro).

Example of properly insulated pipes and collectors.

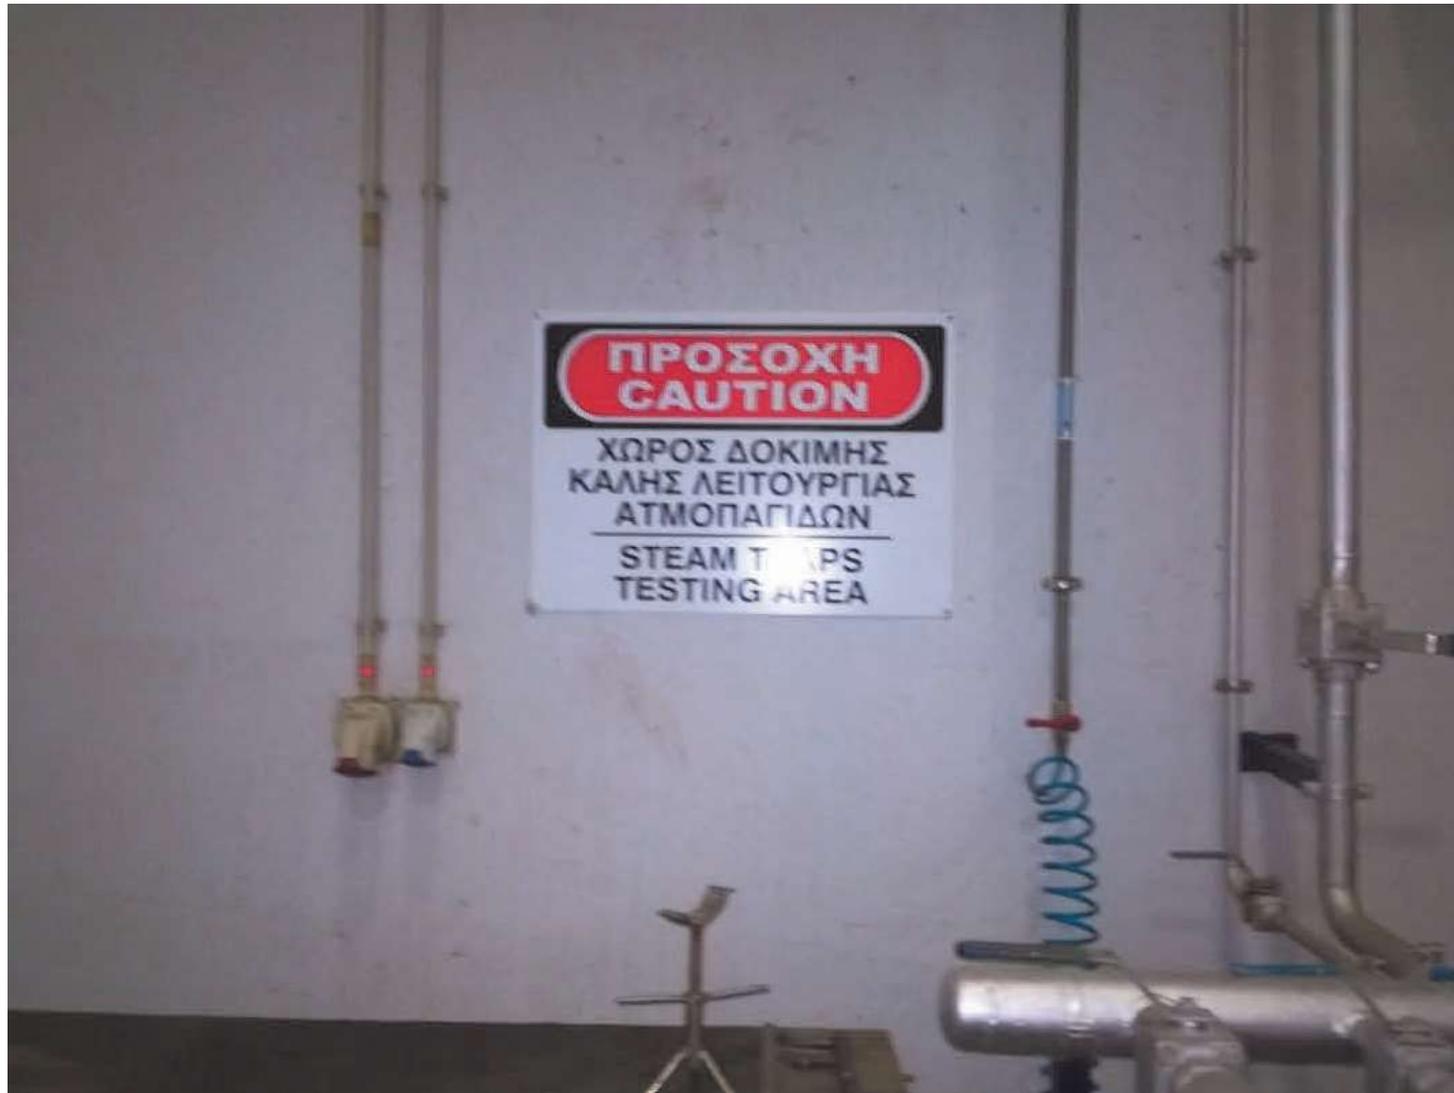
Best case – Steam Trap Testing Area in one of the inspected plants

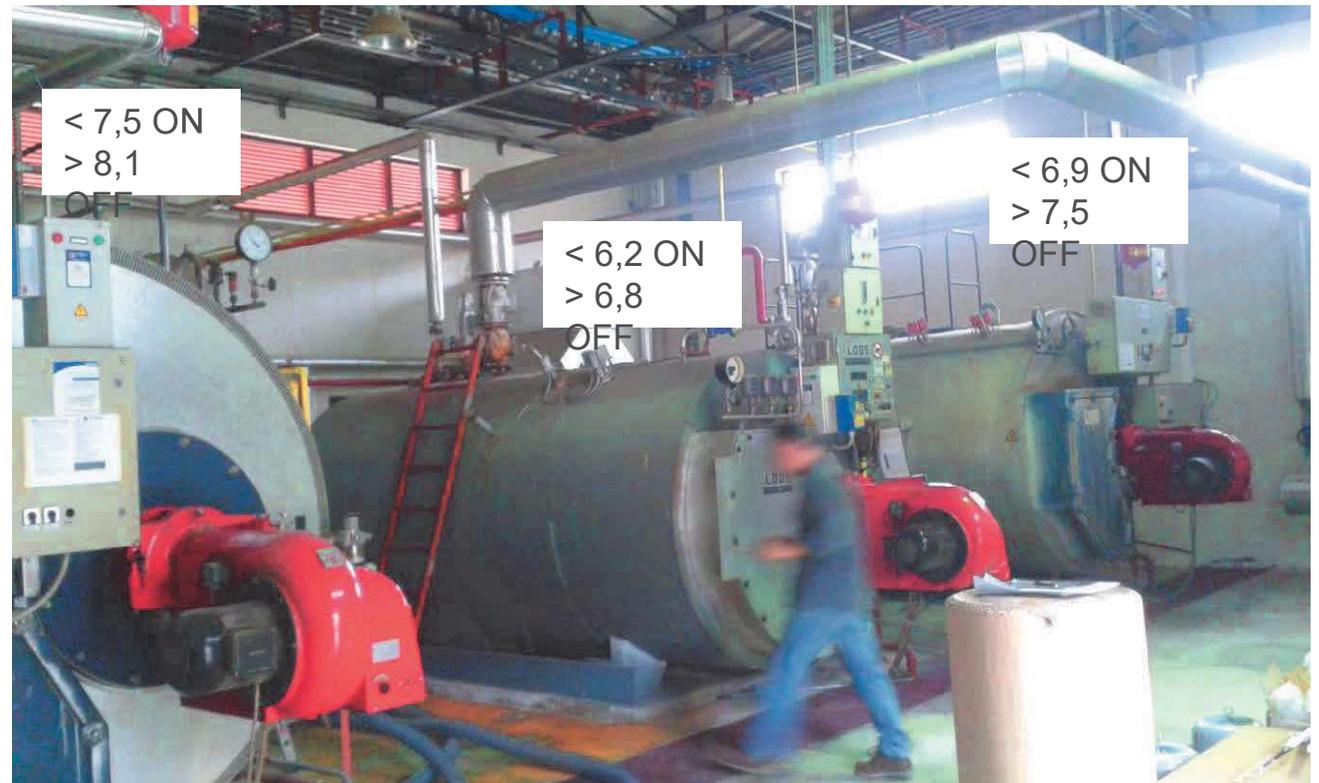
Example of a poorly regulated system. In this example the steam boiler with the lowest boiler efficiency has been set as the MASTER steam boiler. This was correct when initially set but not any more due to its reduced efficiency in the last few years.

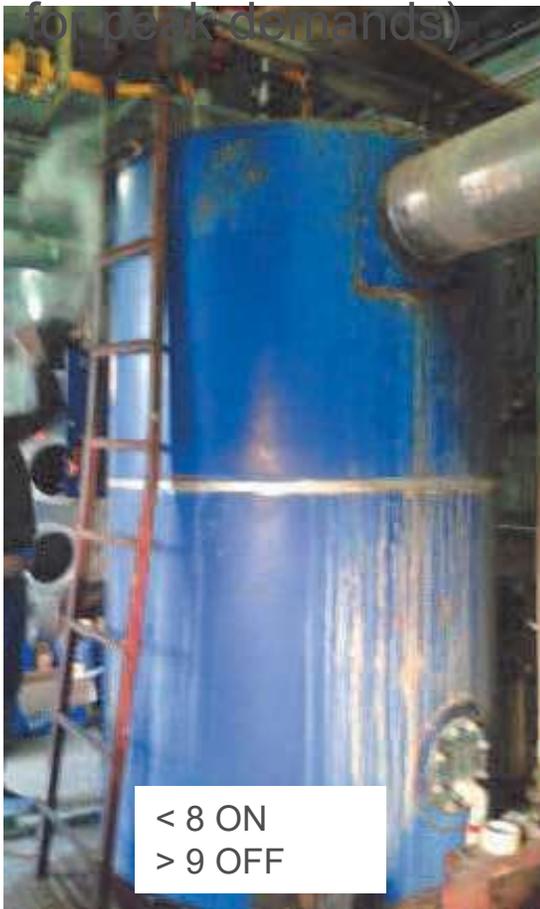
Steam boiler set-points

In 50% of the inspected plants that had both steam boilers and steam generators, their set-points were poorly regulated. As a result of this the steam generators which are able to quickly supply relatively poorer quality steam, did not work according to their foreseen role (i.e. as a back-up source of steam for peak demands)

Examples of poorly regulated steam boiler and generator set points.

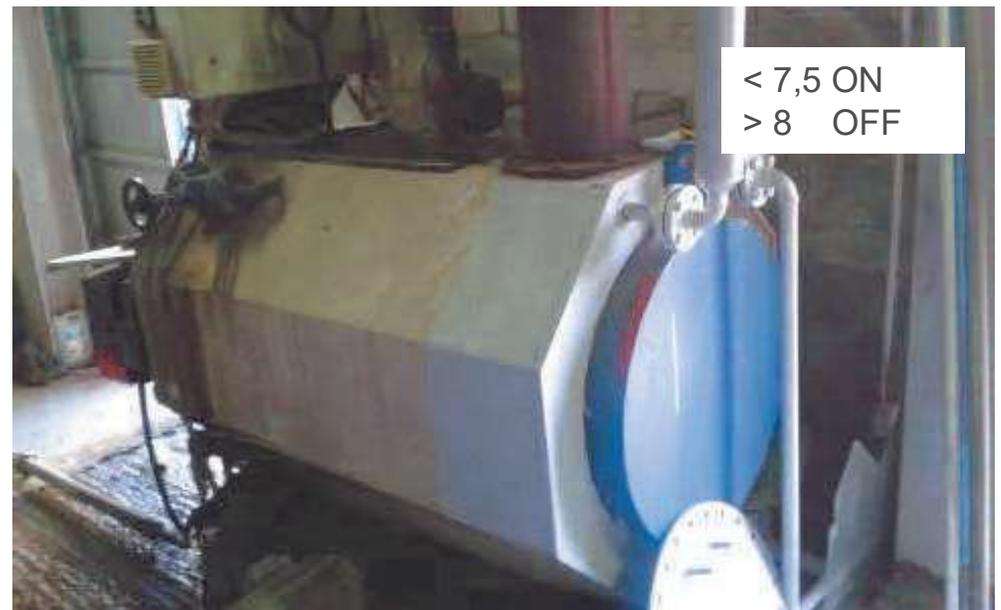
Steam generator set-points

In this inspected plant the roles were inverted. This was ascertained by measuring the steam generations of both boiler and generator using ultrasound flow meters.

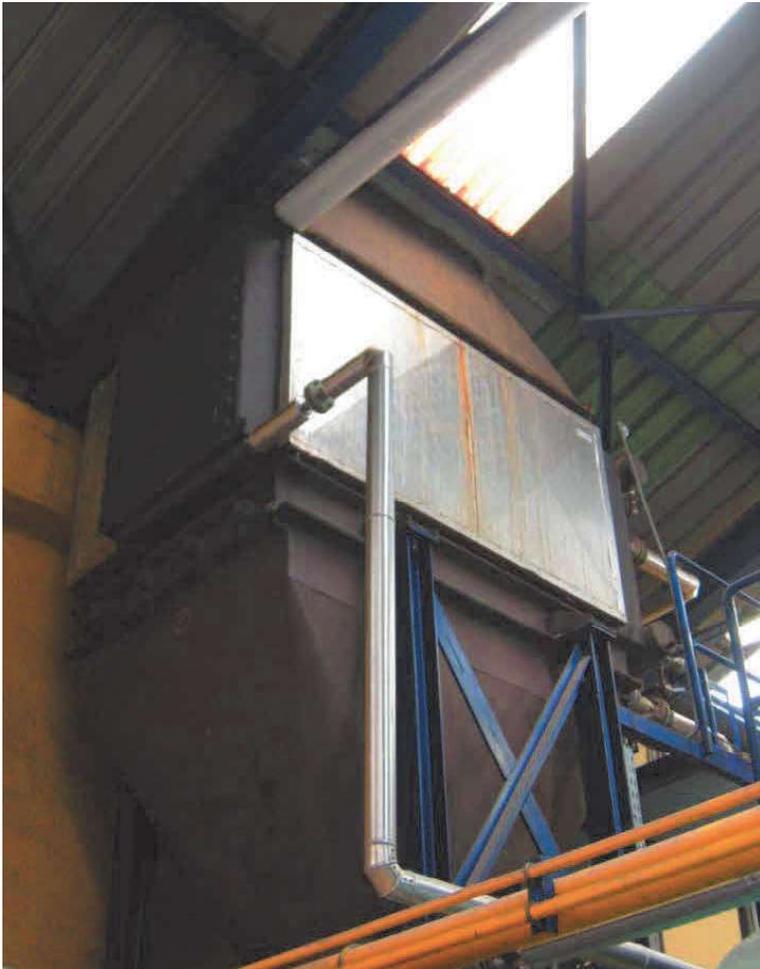
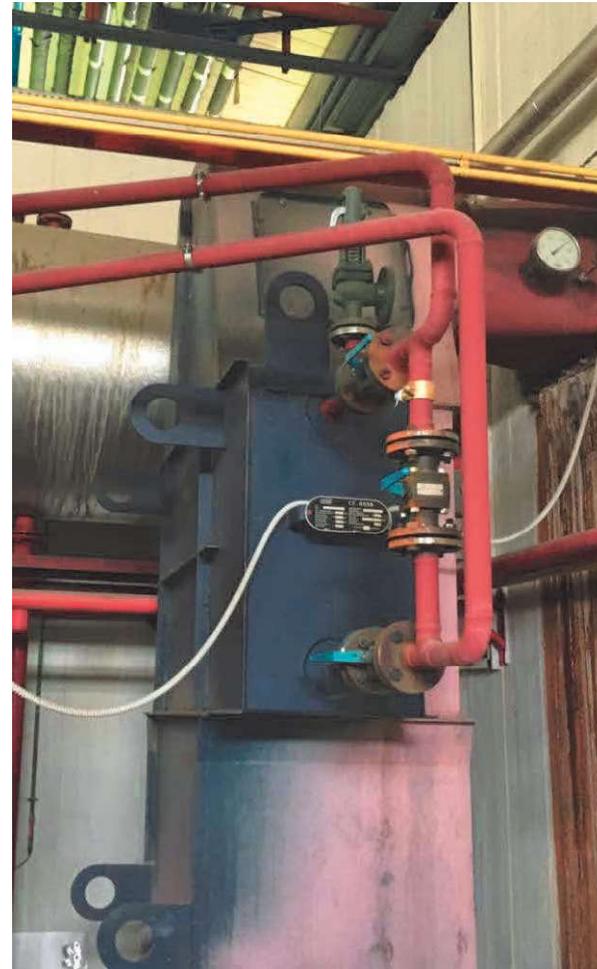
- Even though many of the steam boilers had relatively high flue gas temperatures whose heat could be recovered, only **10% of the inspected steam boilers had installed flue gas economizers** (heat exchangers used to either pre-heat the make-up water of the steam boiler or used directly in the plant processes).

None of the inspected steam boilers had ceramic economizers which allow for the exploitation of flue gas temperatures below the dew point of water.

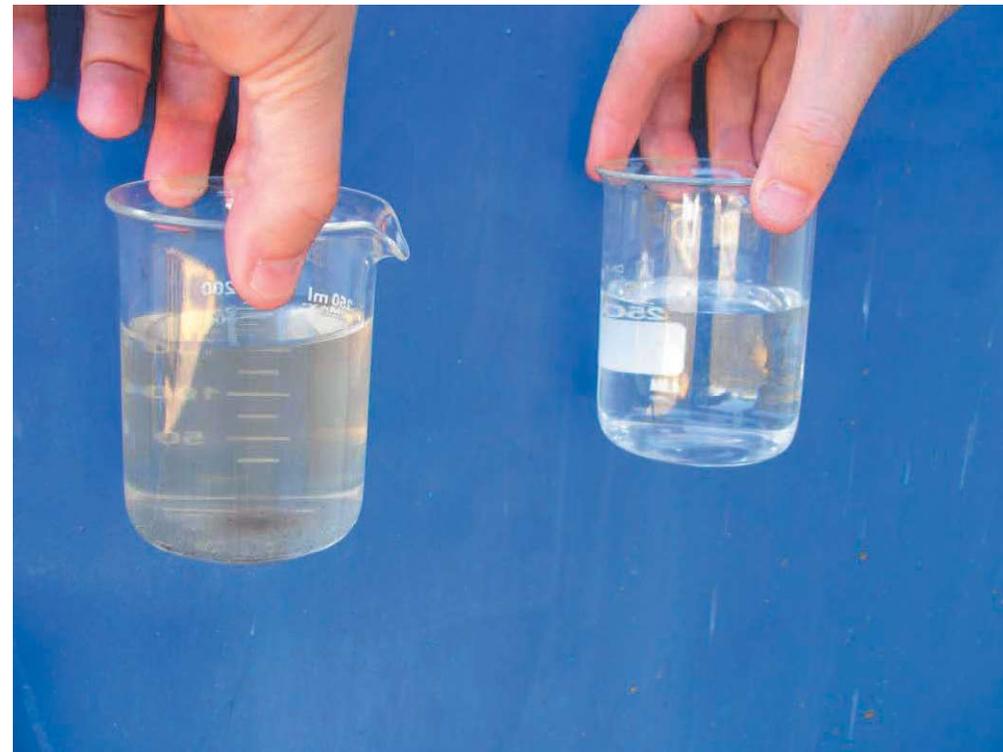
Inspection of the electrical conductivity of the water in the steam boiler (which indicates the concentration of impurities). In most cases it was found that the conductivity was either well below or well above the steam boiler threshold.

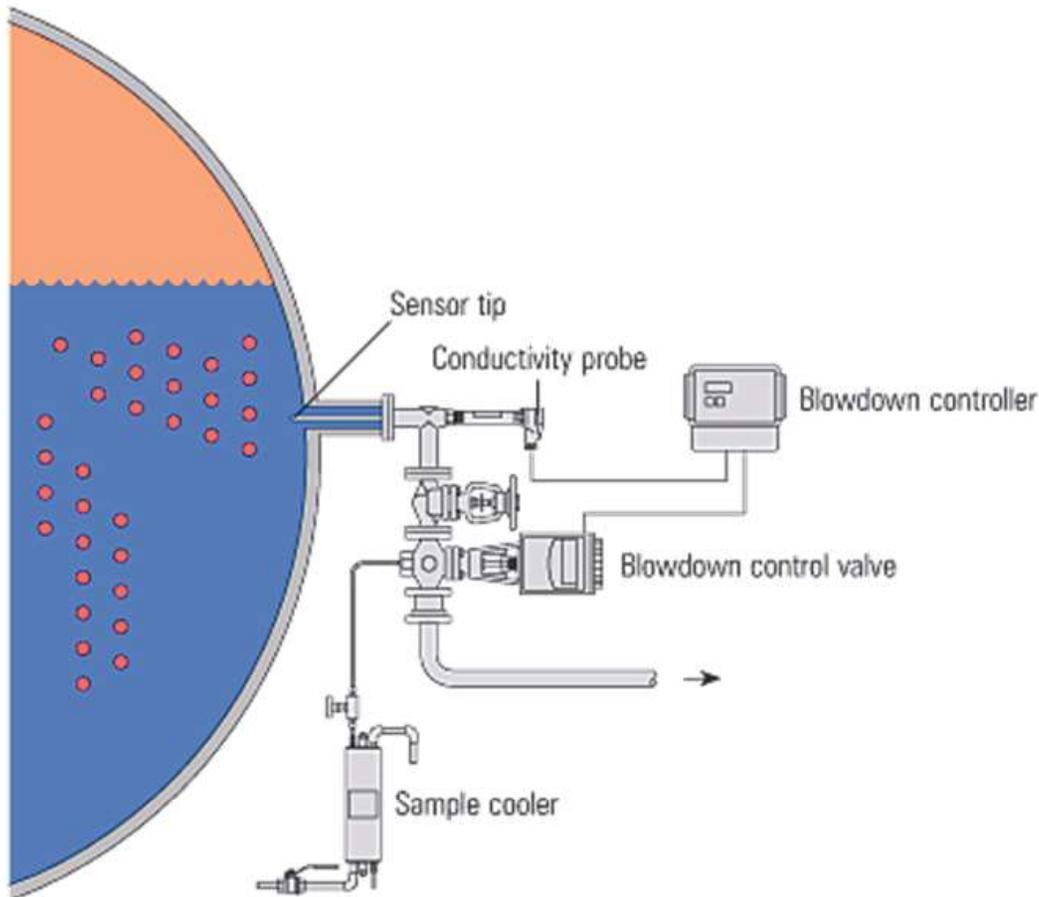
Example of an installed automatic blowdown that is **no longer functional** due to poor maintenance.

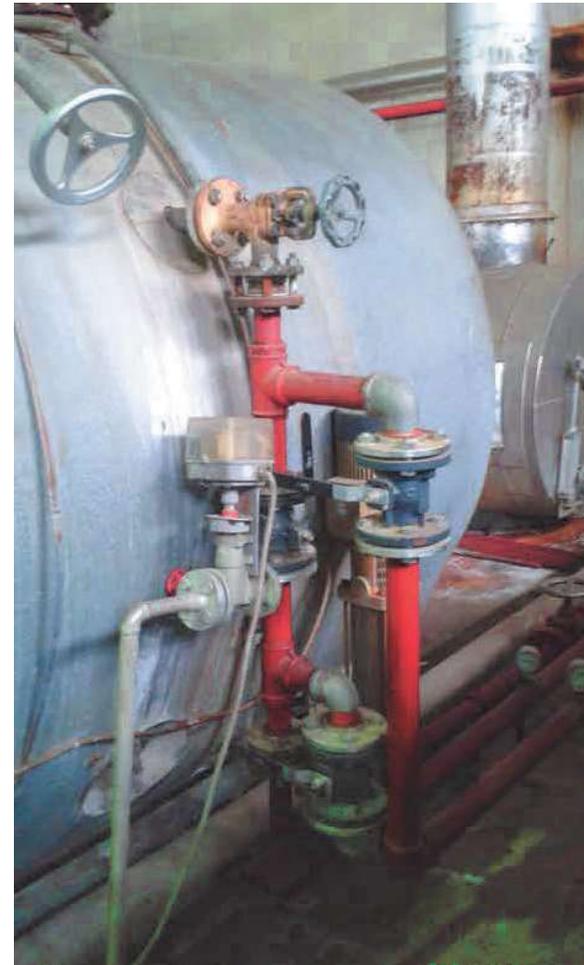
Example of a poorly time-regulated boiler blowdown. The regulation was set-up (15 seconds every 30 minutes) before the installation of the reverse osmosis system (i.e. when the make-up water was very hard water from an underground aquifer). This was not corrected when the reverse osmosis system was installed!

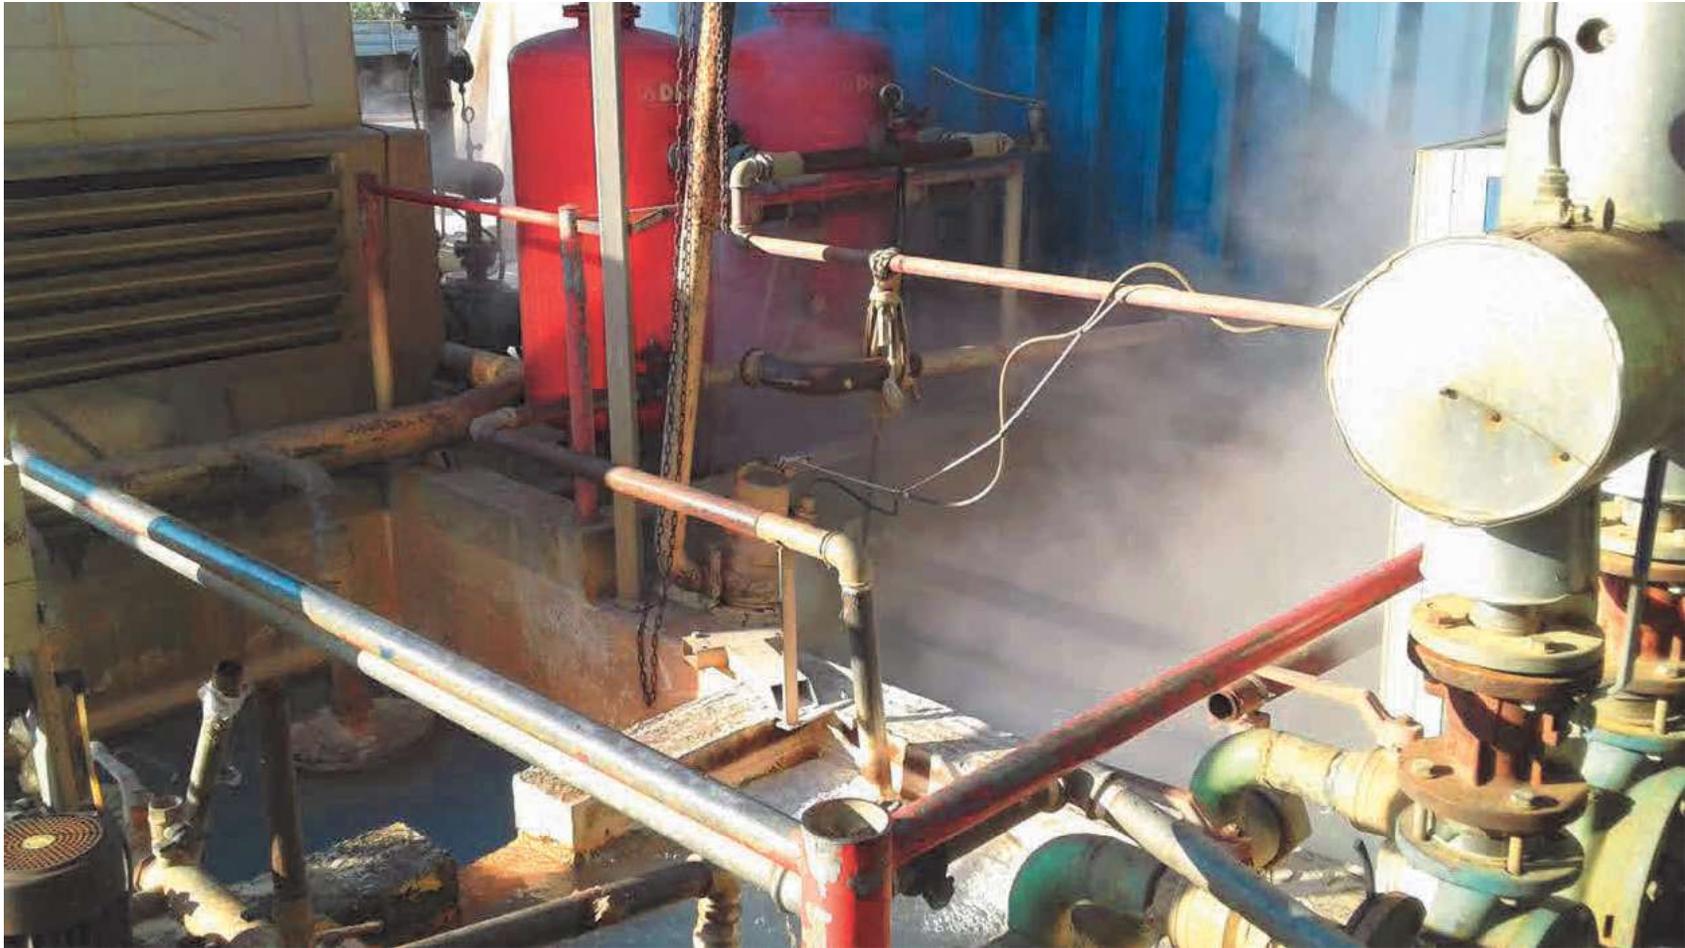
Example of the heat content of boiler blow down not being used. This example concerns one of the inspected plants without an installed reverse osmosis system with more frequent boiler blow down.

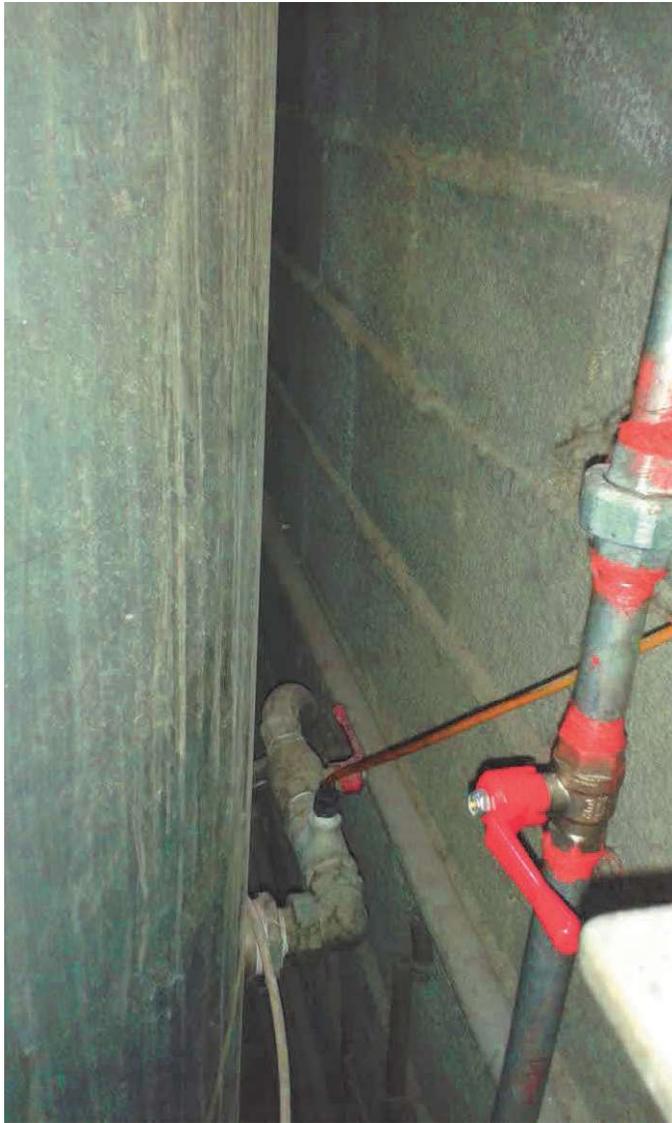
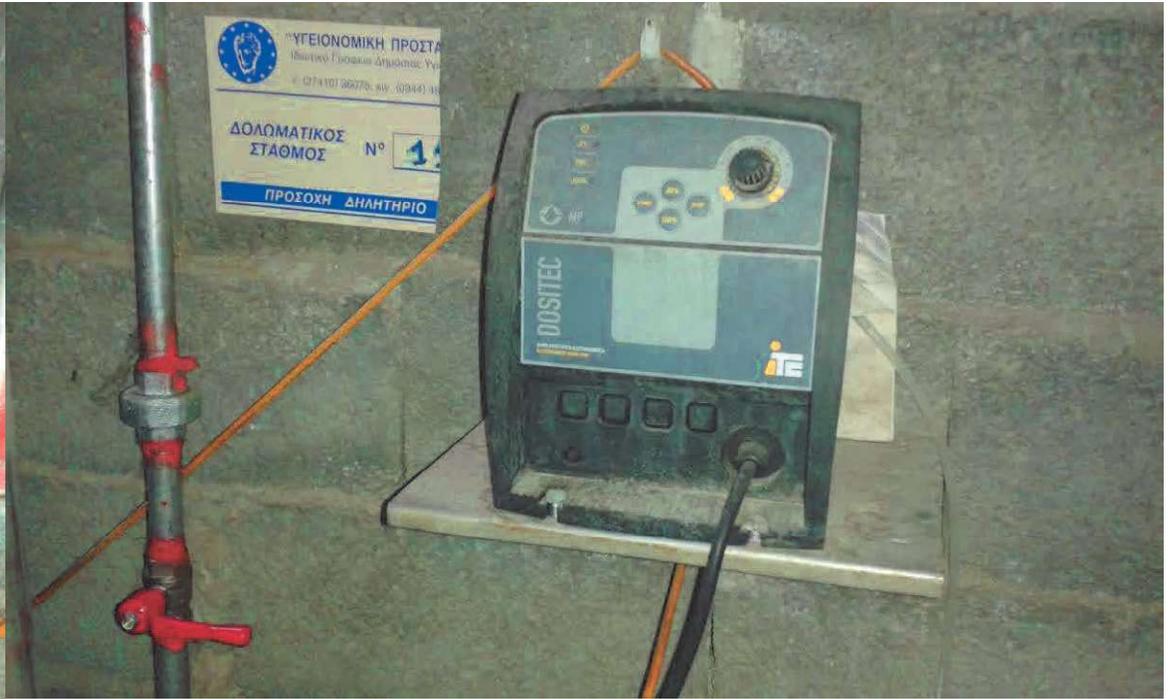
Only in 10% of the inspected plants is flash steam from boiler blowdown and condensate return used to de-aerate the make-up water using flash condensing deaerator heads.

Instead, chemical deaeration is used. This is an alternative that is less environmentally friendly, more expensive and logistically more complex.

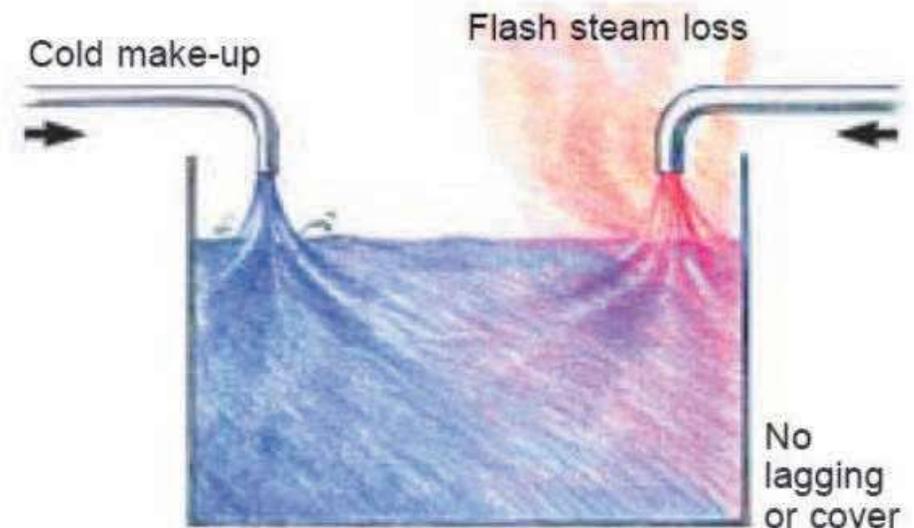
Bad Practice

Examples of an inadequately designed condensate tank. In which the flash steam can be seen escaping the condensate tank.
